REPORT FOR

Building Assessment Churchill School Galesburg, IL

City of Galesburg – Galesburg, IL

14 December 2021

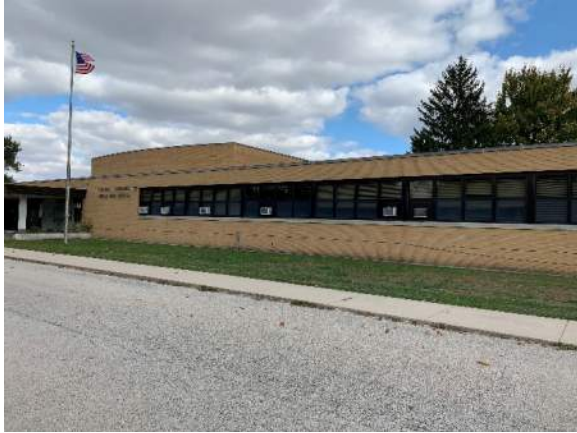
Photo A02 – West Elevation

The building observed is located at 905 Maple Avenue, Galesburg, IL (see Plan A01 and Photo A02). It is a one-story building that presently serves as a junior high school for Galesburg Community Unit School District 205. While there are multiple points of egress throughout the building perimeter, the main entry is located on the west side of the facility. Some parking is included on the north side of the property, with the main parking is located east of the building in an unmarked lot. Major amenities include classrooms/offices, cafeteria, auditorium and stage, two-court gymnasium, wood shop, and interior courtyard. The total area of the building is approximately 87,000 square feet, with the interior courtyard at just under 19,000 square feet. A dedication plaque dated the original construction in 1956. A schematic floor plan of the building is provided at the end of this report for reference.

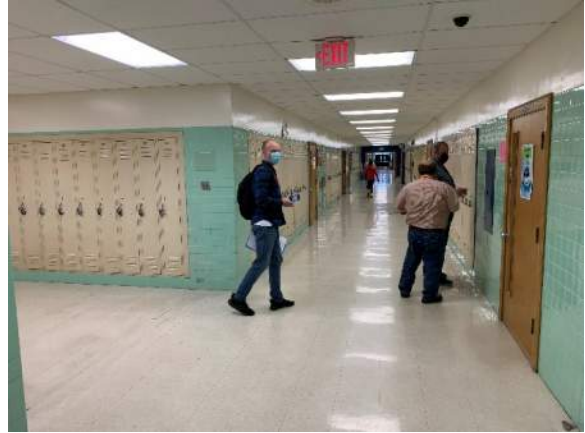
Multiple points of egress were noted in the existing building, so overall egress lengths from the building does not seem to be an issue. However, one area of concern is the apparent lack of fire-rating at the main corridors throughout the entire building (see Photo 03). This was further evidenced by the lack of rated openings, including door grills (see Photo A04). Current use group standards withstanding, corridors would need to have a 1-hour fire-resistance rating due to the building being unsprinklered. While most doors appear to be solid core and may attain the required fire rating, those doors with large openings/grills would need to be replaced.

Photo A03 – Typical Corridor

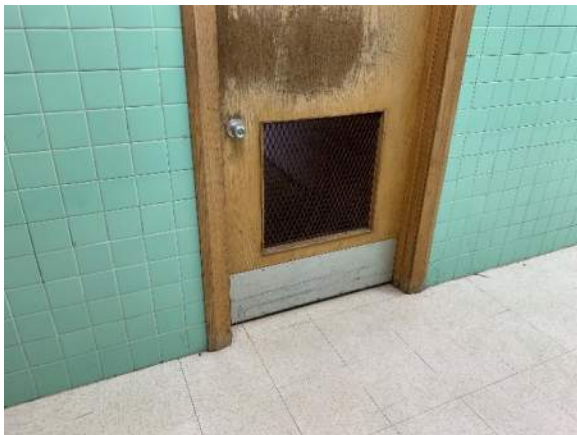
Photo A04 – Corridor Door w/ Grill

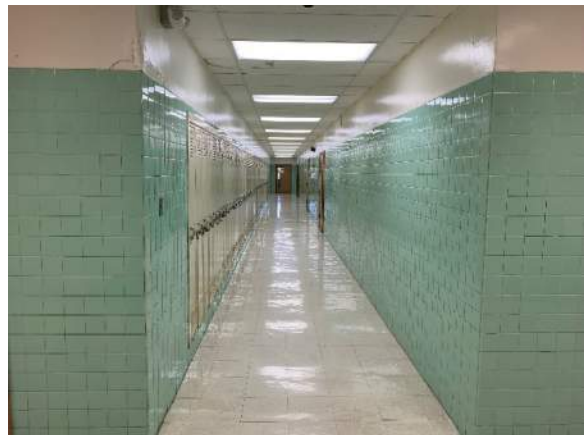
Another area of concern is the hallway adjacent to the east side of the gymnasium (see Photo A05). The north end of this corridor did not continue to an exit or exit access, and in its current state exhibits a dead-end corridor. The allowable distance for this condition is 20'-0" or less, while the actual distance is nearly 80'-0". It is recommended that the renovation provide exit access at this location in particular.

Photo A05 – Dead End Corridor

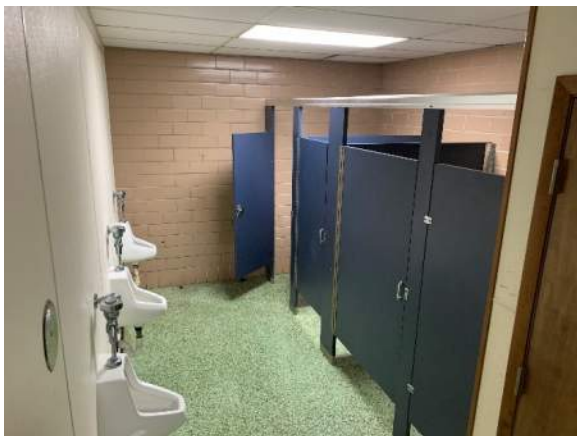
While minor issues regarding Illinois ADA were noted throughout the facility, most of them are related to the lack of compliant restrooms. There is a pair of fully compliant restrooms centrally located near the boiler room, but the rest of the restrooms do not adhere to current standards. These issues include existing door clearances, wheelchair turning clearances, and bathroom accessory mounting criteria (see Photos A06 and A07). These areas should be addressed upon renovation.

Photo A06 – Typical Restroom

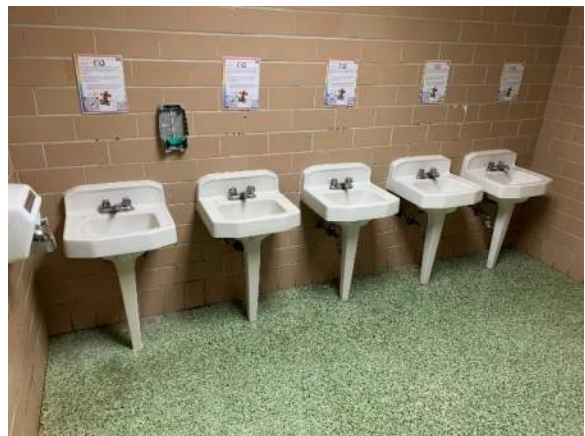
Photo A07 – Typical Restroom

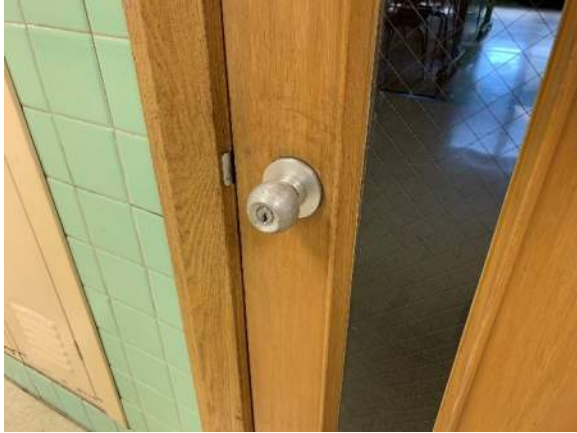
An additional issue regarding accessibility was the door handles typically found throughout the building. While the main egress doors exhibited lever operation, the typical door hardware at classrooms and offices utilized doorknobs (see Photo A08). Per Section 309.4 of 2018 Illinois Accessibility Code, "Operable parts shall be operable with one hand and shall not require tight grasping, pinching, or twisting of the wrist". This hardware would need to be replaced as the renovation progresses.

Photo A08 – Non-compliant Door Handle

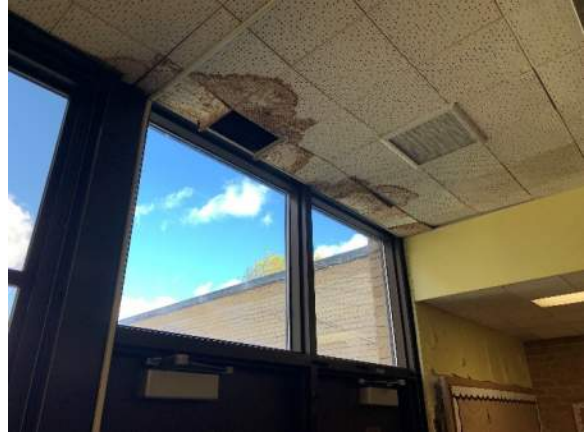
Some evidence of past water intrusion was observed in the building, most notably in the library area (see Photo A09). While the ceiling panels have not been replaced, the damage does not appear to be recent, and it is assumed that the intrusion has been abated. It was also mentioned that there was a recent roof leak at the north side of the gym (see Photos A10 and A11). Upon discussion, this repair has already taken place, and there was not further issue at the time of this report.

Photo A09 – Water Intrusion Damage

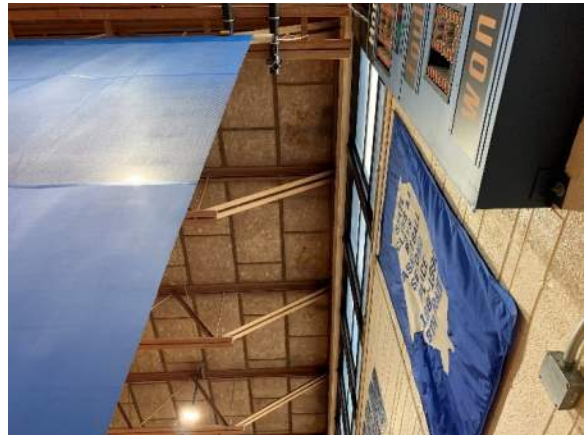
Photo A11 – Water Intrusion (Gym)

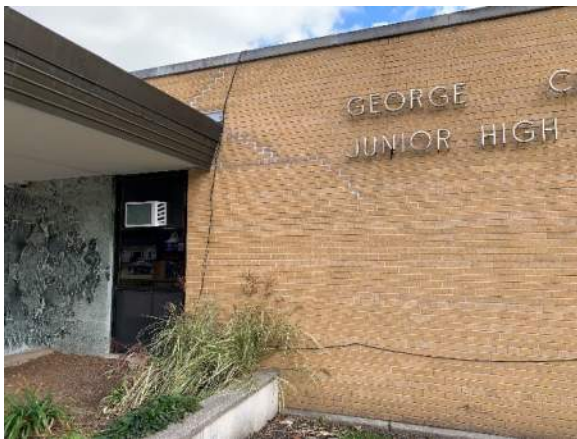
The brick veneer is also in good condition for a building of this age. Certain areas, however, require tuckpointing and minor repair in order to maintain the building envelope (see Photos A12 – A14). The boiler chimney in particular needs immediate repair (see Photo A15). Other areas indicating sealant in lieu of mortar should also be addressed in the various repair. Past repair and/or brick replacement was noted at the northwest corner of the building.

Photo A12 – Tuckpointing at West Elevation

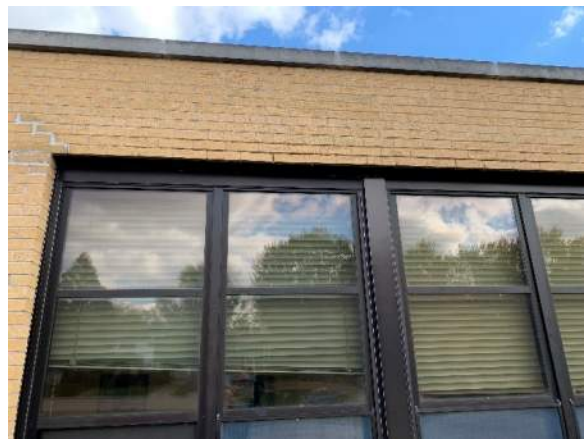
Photo A13 – Tuckpointing, Typical

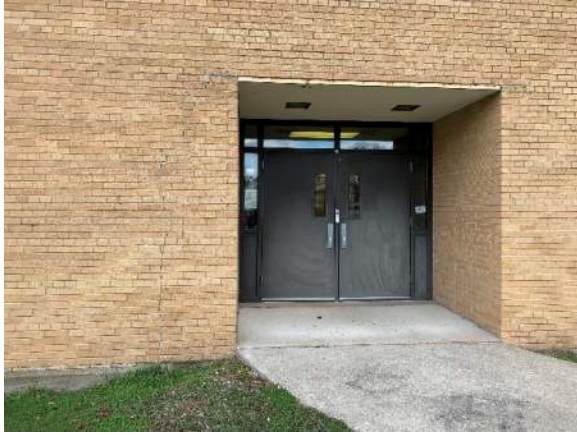
Photo A14 – Masonry Repair, East Elevation

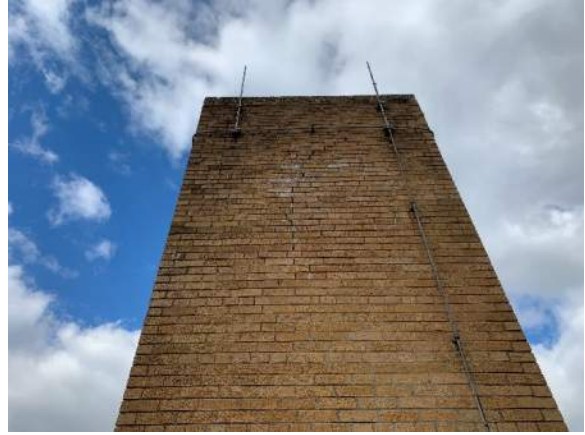
Photo A15 – Masonry Repair, Chimney

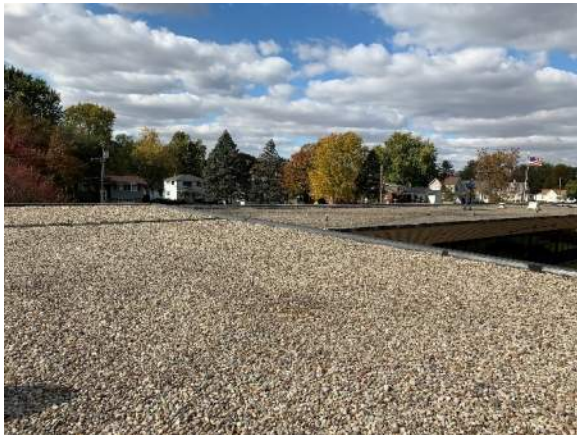
As previously mentioned, a portion of the ballasted EPDM roof system was recently replaced at the south side of the building (see Photo A16). The remainder of the roofing at the lower areas appears to be in fair condition, although a more in-depth analysis may be required (i.e., due to the ballast covering the membrane). The high roof of the gymnasium/auditorium seems to exhibit more wear and warrants replacing in the next 5 years (see Photo A17). The age of the older roof was not determined, although the lifetime of similar systems may be 20-25 years. Expansion joints separating the various wings of the building were found to be in good condition. A portion of the coping and roof edge appeared to have been recently repaired at the area of the roof leak at the gym. Please note that proposed roof work would also include coping repair/replacement and miscellaneous flashing.

Photo A16 – New/Old Roof (Lower)

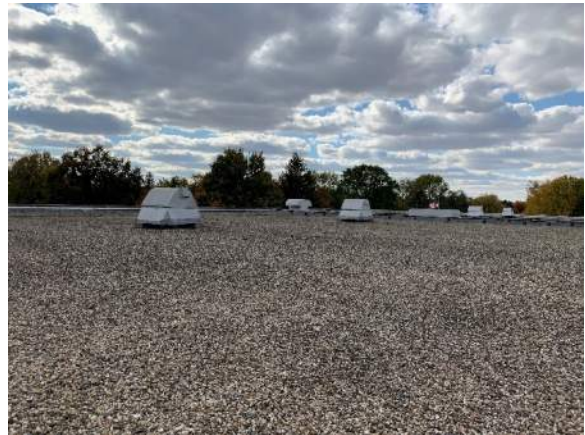
Photo A17 – Gymnasium Roof (Upper)

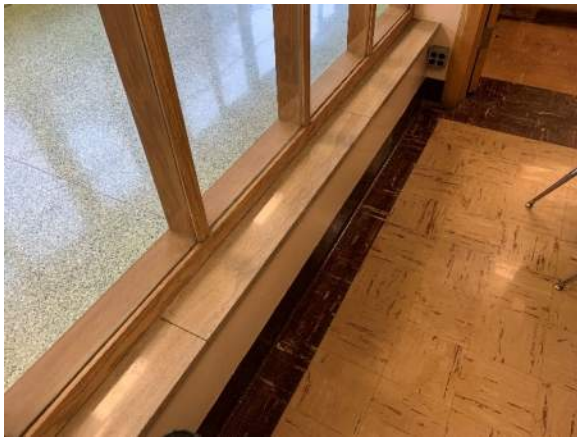
Interior finishes vary greatly throughout the facility. Floor finishes include terrazzo, ceramic tile, vinyl tile, carpeting, exposed concrete, and apparent asbestos tile (see Photos A18 and A19). Wall finishes observed were painted plaster, ceramic wall tile, painted gyp. board, glazed block, brick, and painted CMU. Ceiling finishes consist of suspended acoustical ceiling panels, tectum panels (at the gym), plaster (at the auditorium), and apparent direct applied asbestos ceiling tile (see Photo A20).

Hazardous material is expected in some of the finishes found throughout the building. These include asbestos floor and ceiling tile, as well as potential lead paint (see Photo A21). While the tile may be left in place and covered over (as applicable to manufacturer's recommendations), the paint may need to be abated. It appears that at least some abatement will be required due to failing floor/ceiling tiles. It is highly recommended that these materials be tested for confirmation.

Photo A18 – Terrazzo & Asbestos Floor Tile

An outlying factor is addressing the hazardous material as previously mentioned. It is recommended that, when possible, the floor/ceiling tile be left in place and covered with an appropriate finish. In this way the renovation may be economically provided without the need for full abatement.

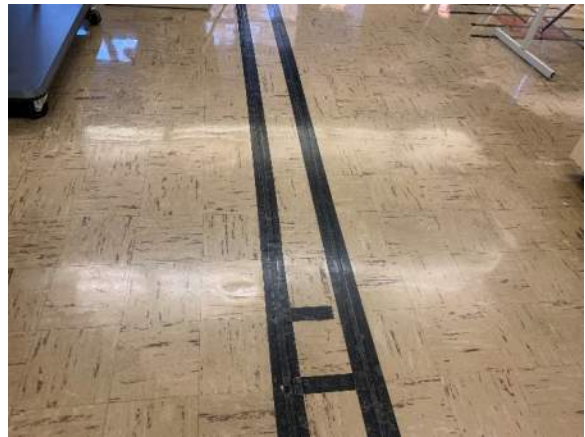
Photo A19 – Asbestos Floor Tile

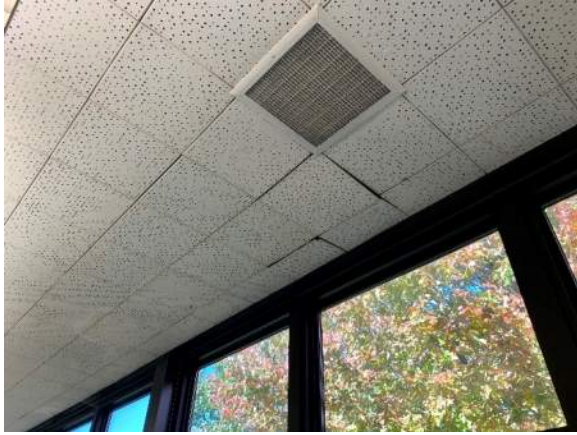
Photo A20 – Asbestos Ceiling Tile

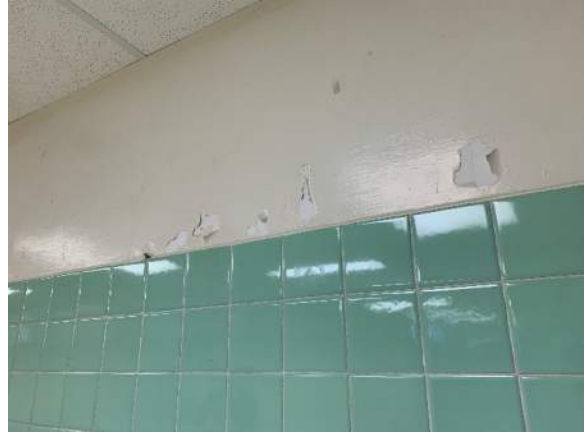
Photo A21 – Painted Finish (at Corridor)

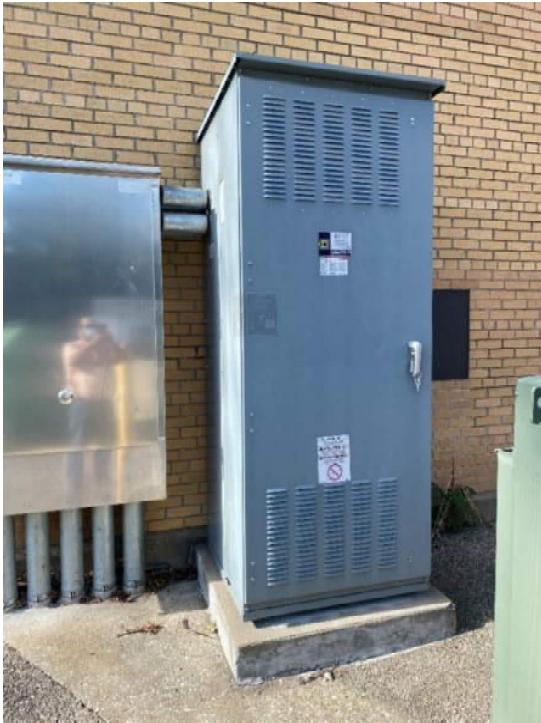
Regarding Power, the existing service entrance equipment was replaced in recent years and includes a 1600-amp 120/208-volt 3 phase 4 wire service entrance switch located exterior and in the rear of the building. Ameren reports a peak demand on the service of 70 kVA (194 amps) Fed from a 300 kVA transformer. This allows for the 230 kVA (638 amps) spare capacity for future work. This switch is in great shape and has many years of service life available (see Photo E01).

Photo E01 – Service Entry Switch

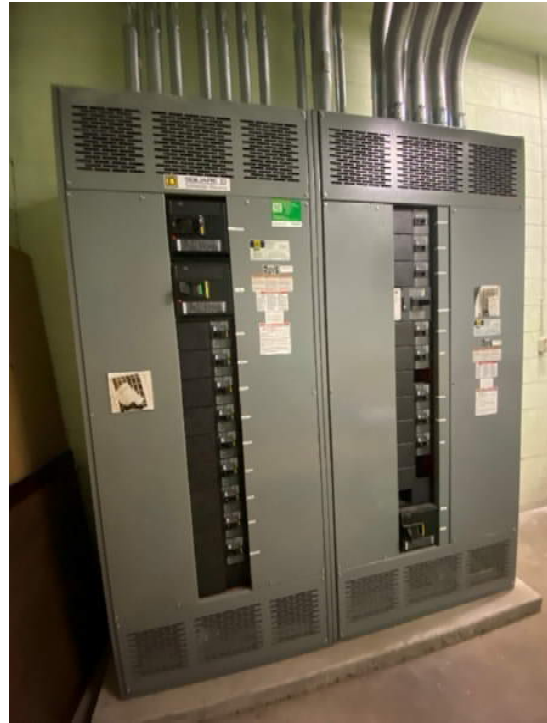
The service entrance switch feeds a 1600-amp main distribution board (MDP) in the lower-level electrical room (within the boiler room). The MDP is of the same age as the service entrance switch and is also in great shape (see Photo E02).

Photo E02 – Main Distribution Panel

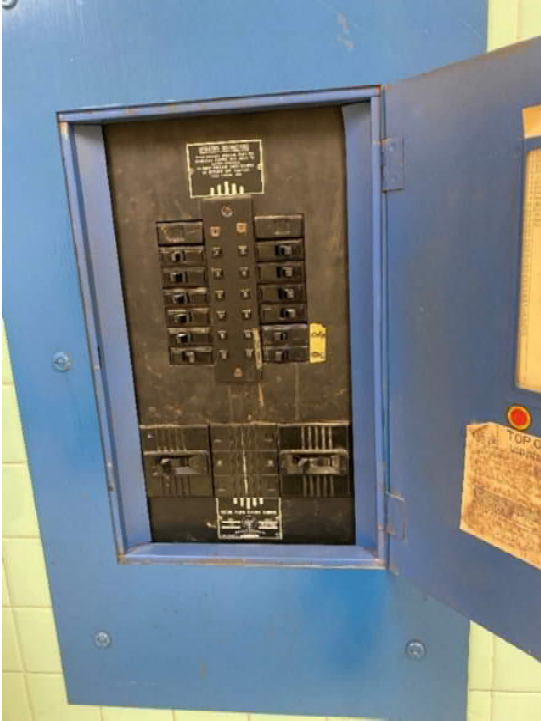
There are several branch circuit panel boards throughout the facility, these however are part of the original building construction (circa 1975) and have met their expected service life. The manufacturer is

no longer in business and replacement parts are extremely hard to find, and if found are salvaged material and not reliable (see Photo E03 for typical panel).

Photo E03 – Branch Circuit Boards

Replace all branch circuit boards in the facility.

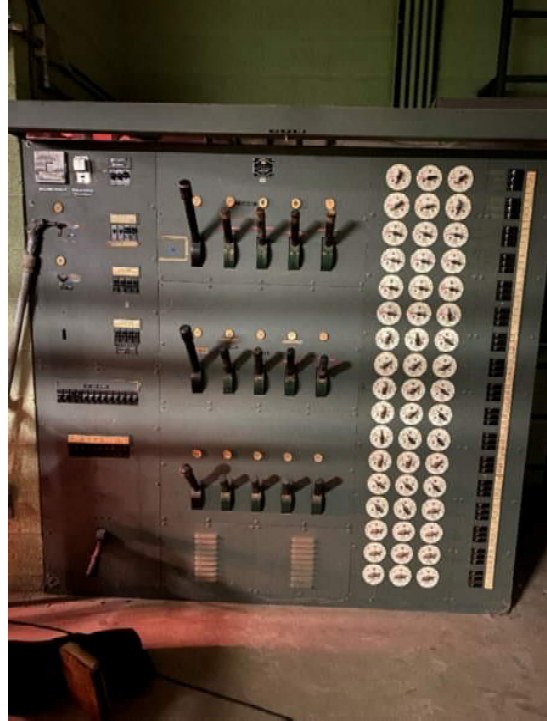
The Auditorium has a 50+ year theatric dimming system that has met its end of useful life (see Photo E04).

Photo E04 – Theatric Lighting System
