REPORT FOR

Building Assessment Churchill School Galesburg, IL

City of Galesburg – Galesburg, IL

14 December 2021

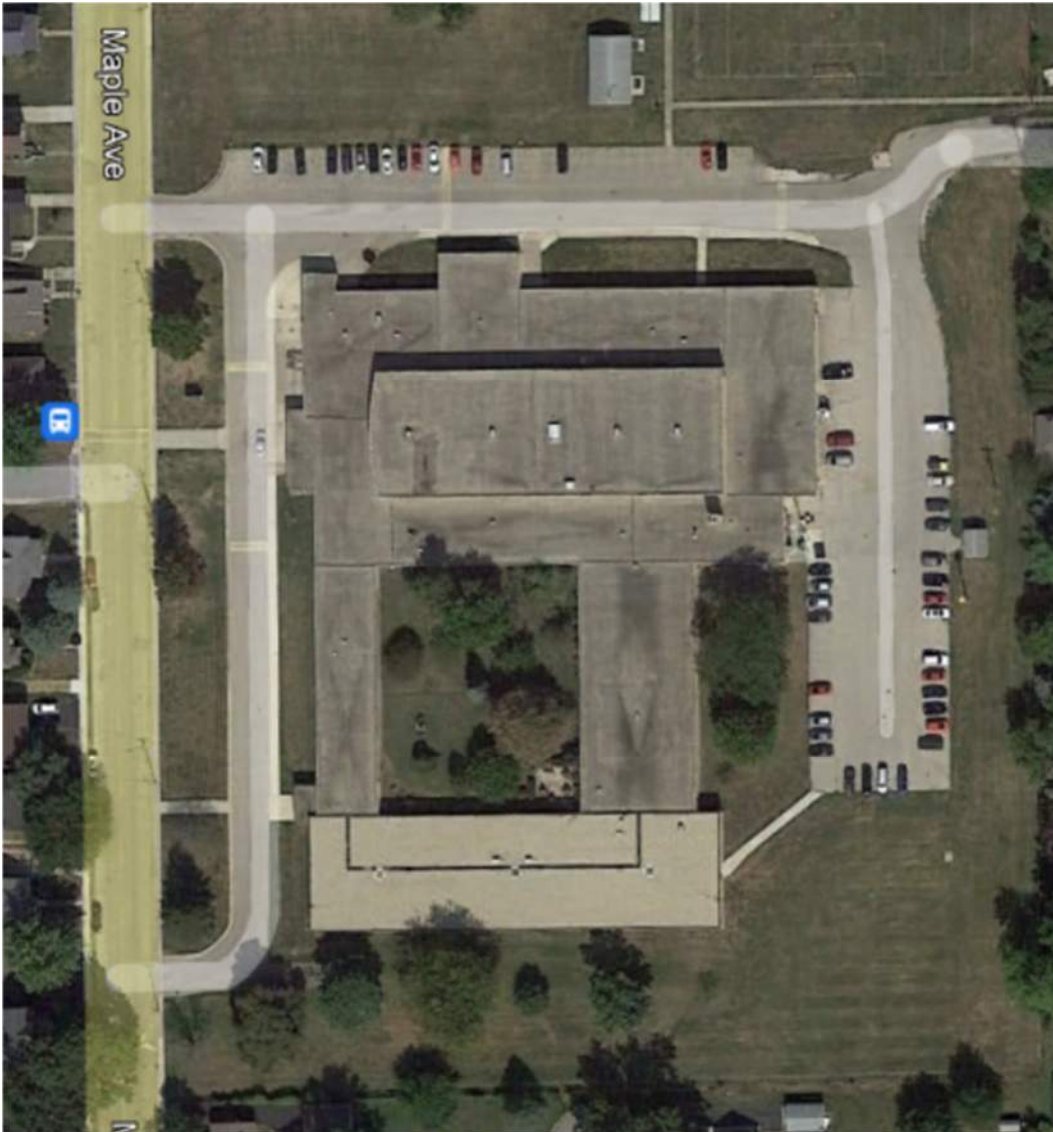
Photo A01 – Site Plan of Facility (Google Maps); North is top of the page.

The building observed is located at 905 Maple Avenue, Galesburg, IL (see Plan A01 and Photo A02). It is a one-story building that presently serves as a junior high school for Galesburg Community Unit School District 205. While there are multiple points of egress throughout the building perimeter, the main entry is located on the west side of the facility. Some parking is included on the north side of the property, with the main parking is located east of the building in an unmarked lot. Major amenities include classrooms/offices, cafeteria, auditorium and stage, two-court gymnasium, wood shop, and interior courtyard. The total area of the building is approximately 87,000 square feet, with the interior courtyard at just under 19,000 square feet. A dedication plaque dated the original construction in 1956. A schematic floor plan of the building is provided at the end of this report for reference.
